**BOEING AIRPLANE COMPANY**  
**WICHITA, KANSAS**

DOCUMENT NO. WD-14018 DATE January 31, 1956

MODEL BC-47E CONTRACT NO. 5148

TITLE ANALYSIS OF WFT-709 FLIGHT TESTS OF NAVIGATOR'S  
COMPARTMENT DEFROSTING SYSTEM

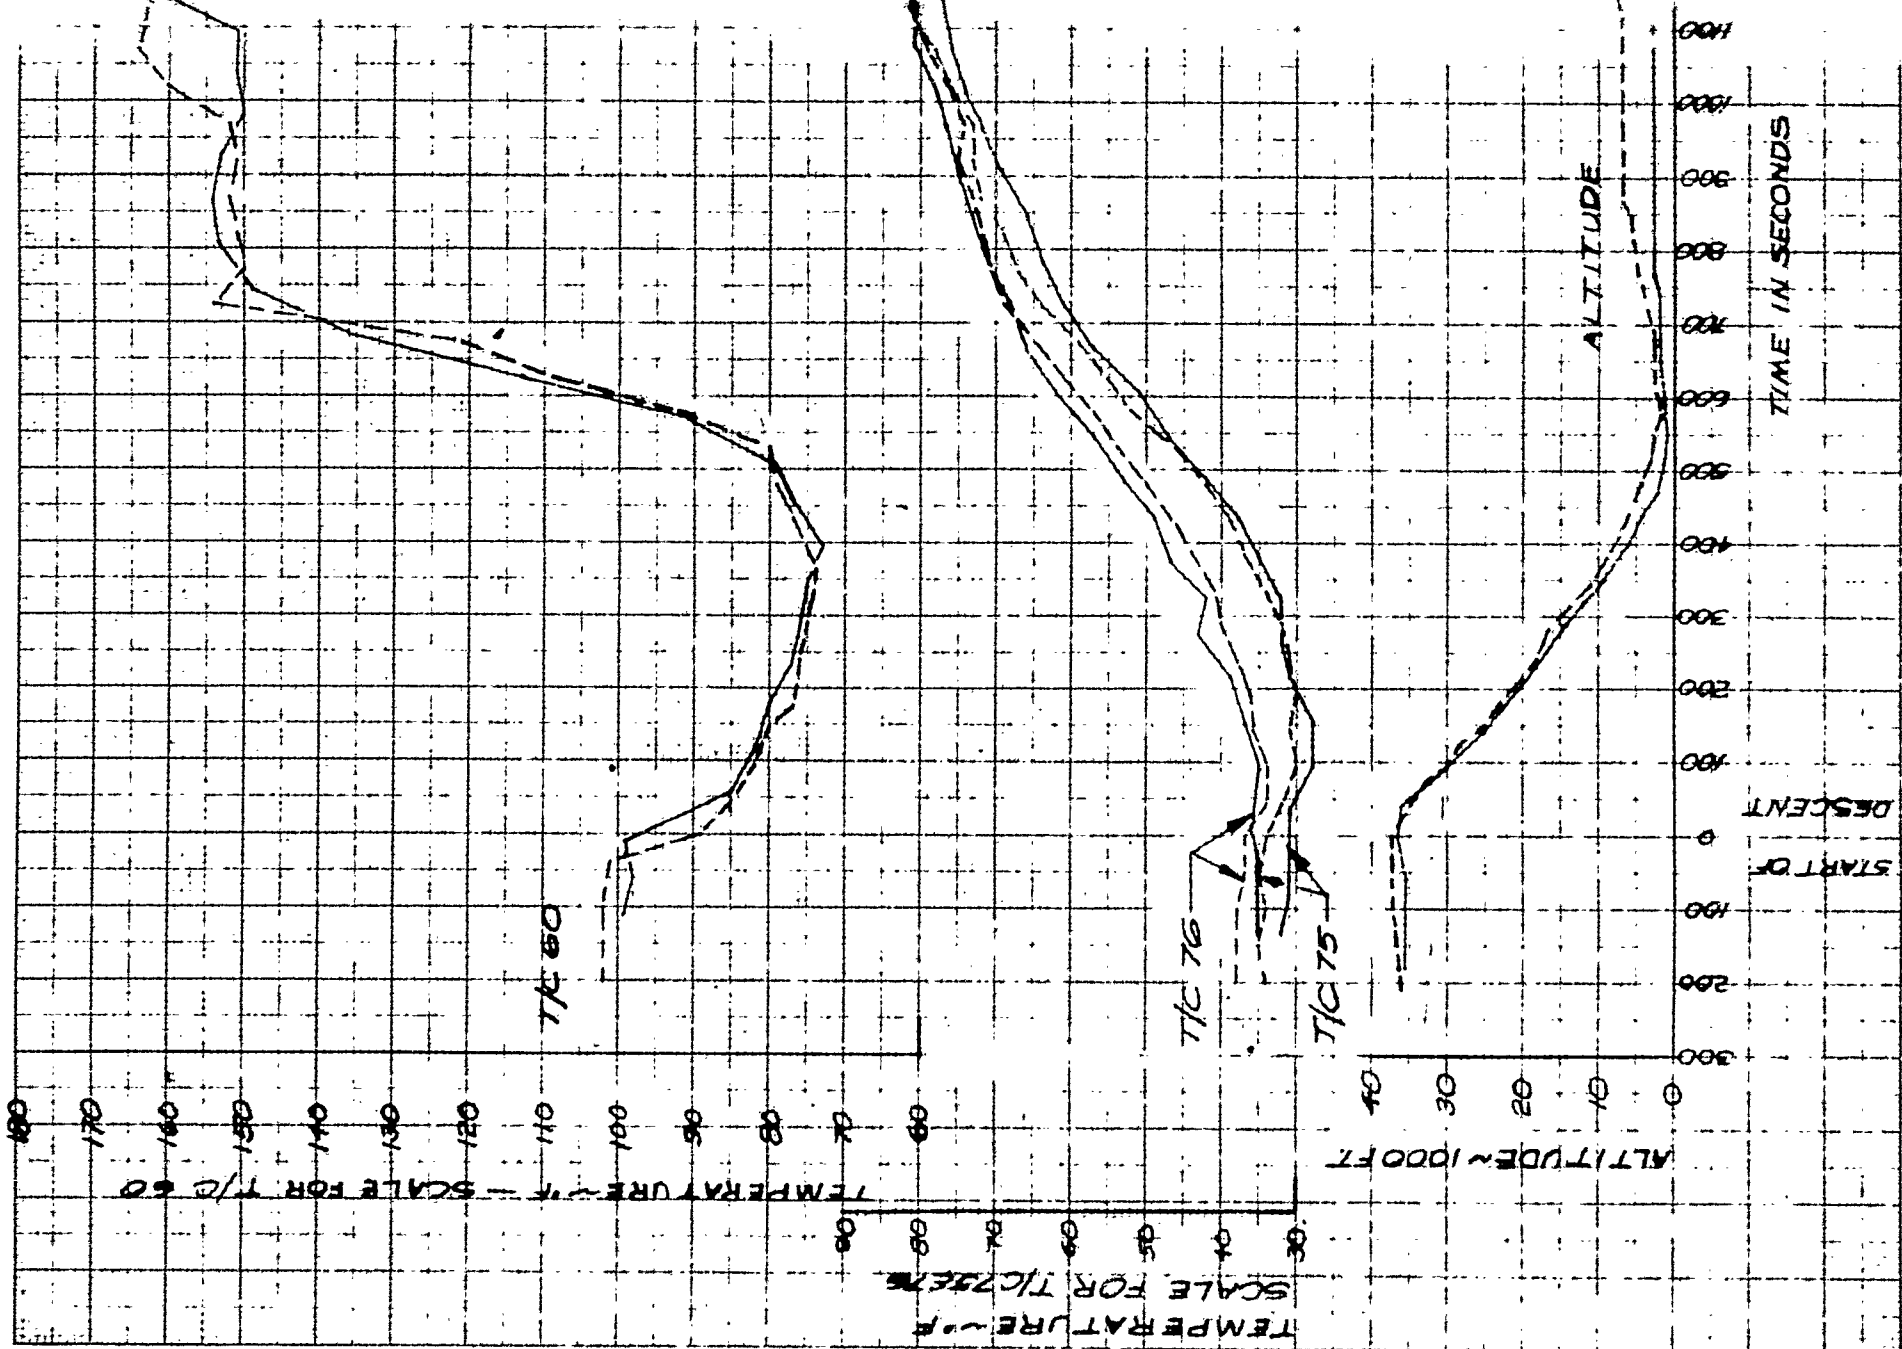
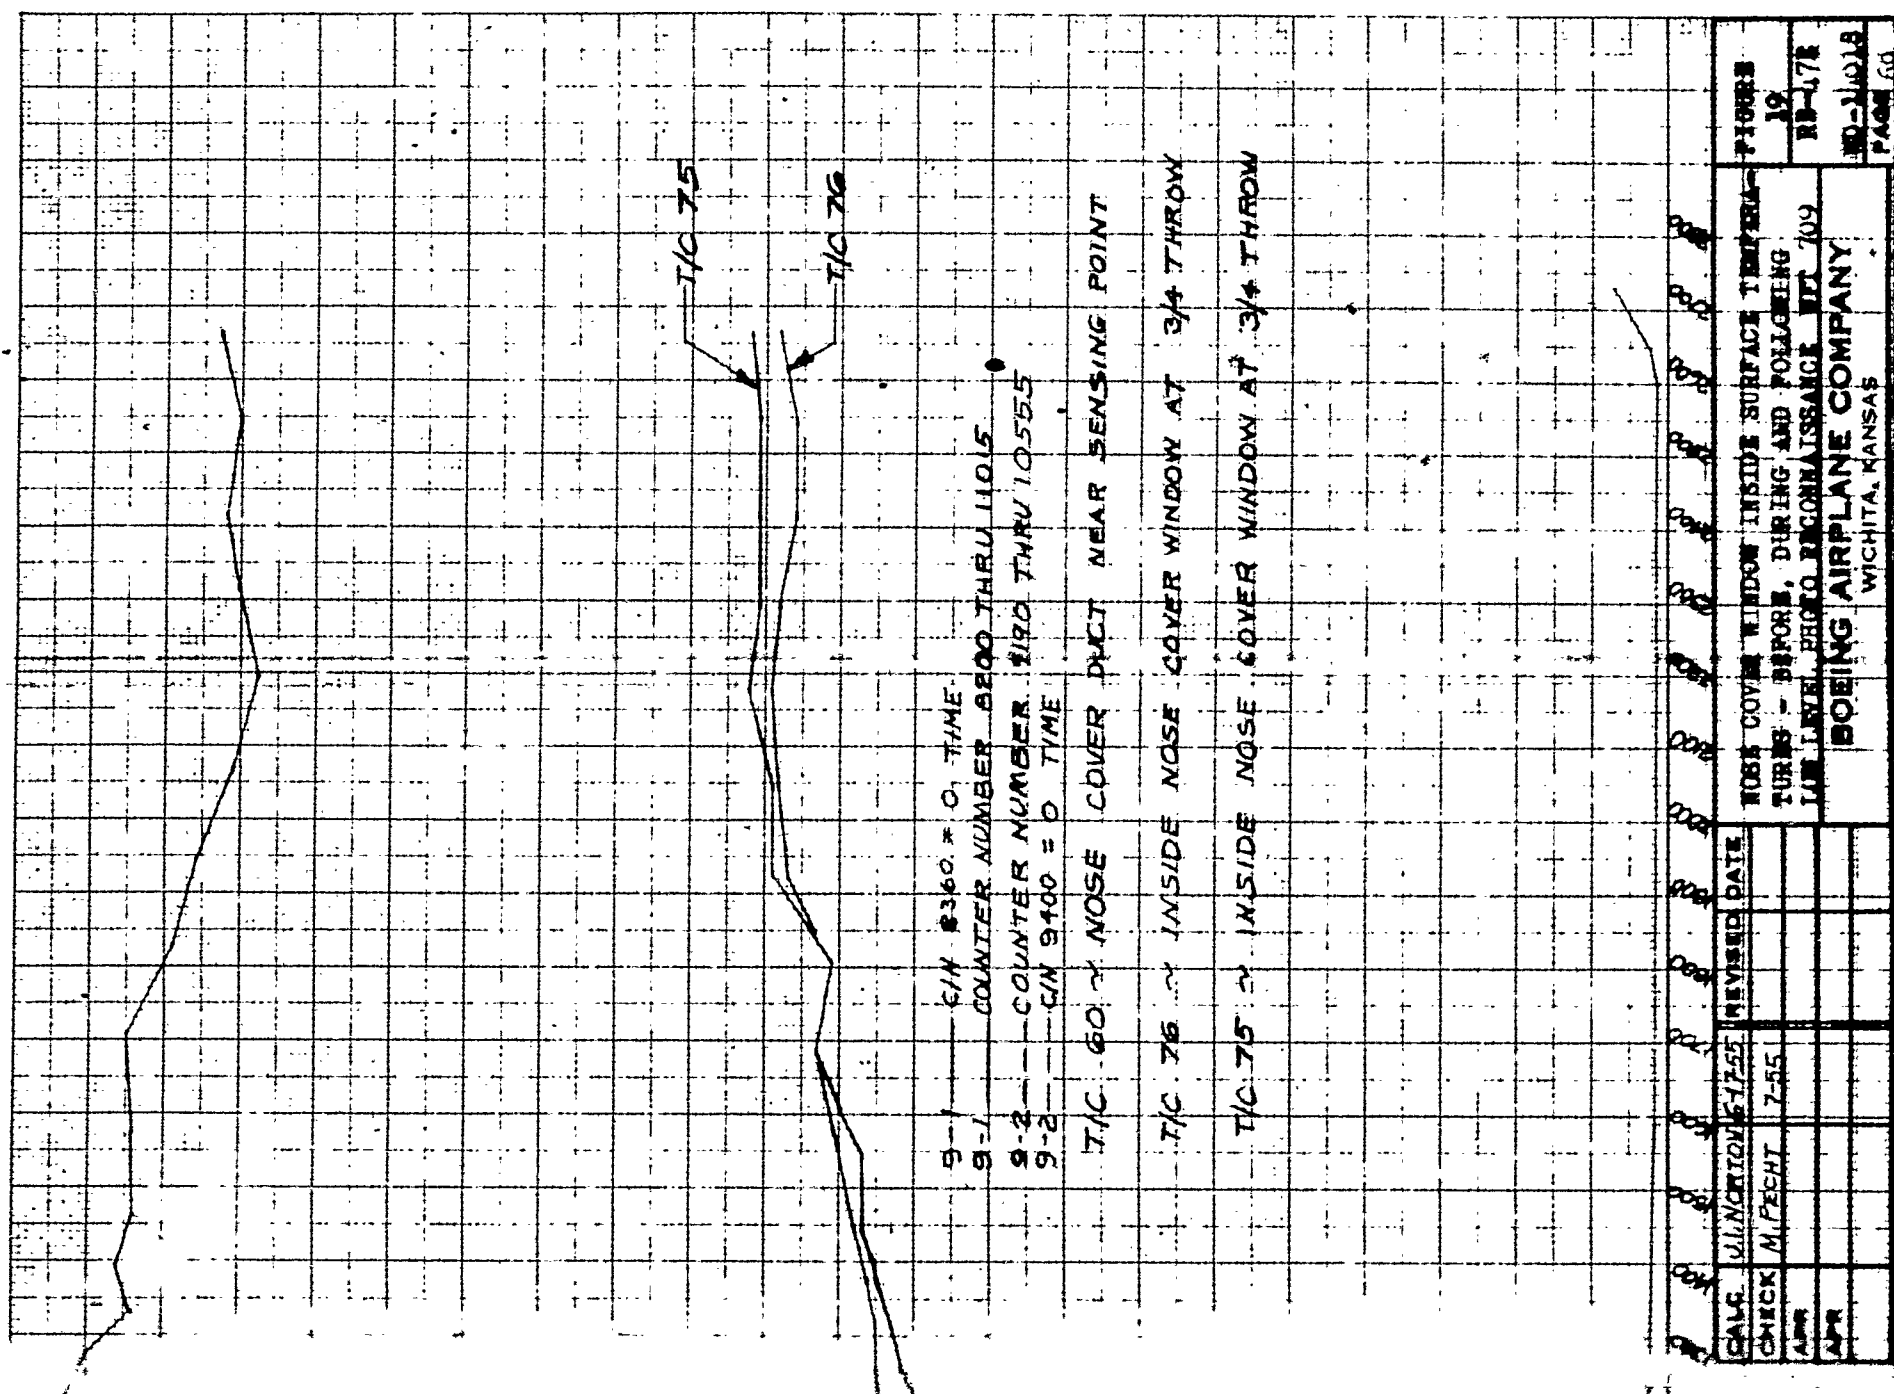
9-1 CIN 8360 \* 0 TIME  
9-1 COUNTER NUMBER 8200 THRU 11015  
9-2 COUNTER NUMBER 1180 THRU 10555  
9-2 CIN 9400 = 0 TIME

T/C 60 ~ NOSE COVER DUCT NEAR SENSING POINT  
T/C 75 ~ INSIDE NOSE COVER WINDOW AT 3/4 THROW  
T/C 76 ~ INSIDE NOSE COVER WINDOW AT 3/4 THROW

DATE	UNION	7-55	REVISED DATE	NOSE COVER WINDOW INSIDE SURFACE TEMPERATURES - BEFORE, DURING AND FOLLOWING TURN - 180 DEGREE ENCOUNTERS AT 700	FIGURE 19
CHECK	M. FECHT	7-55			
APR					
APR					
BOEING AIRPLANE COMPANY				WICHITA, KANSAS	
CONTRACT NO.				PAGE 69

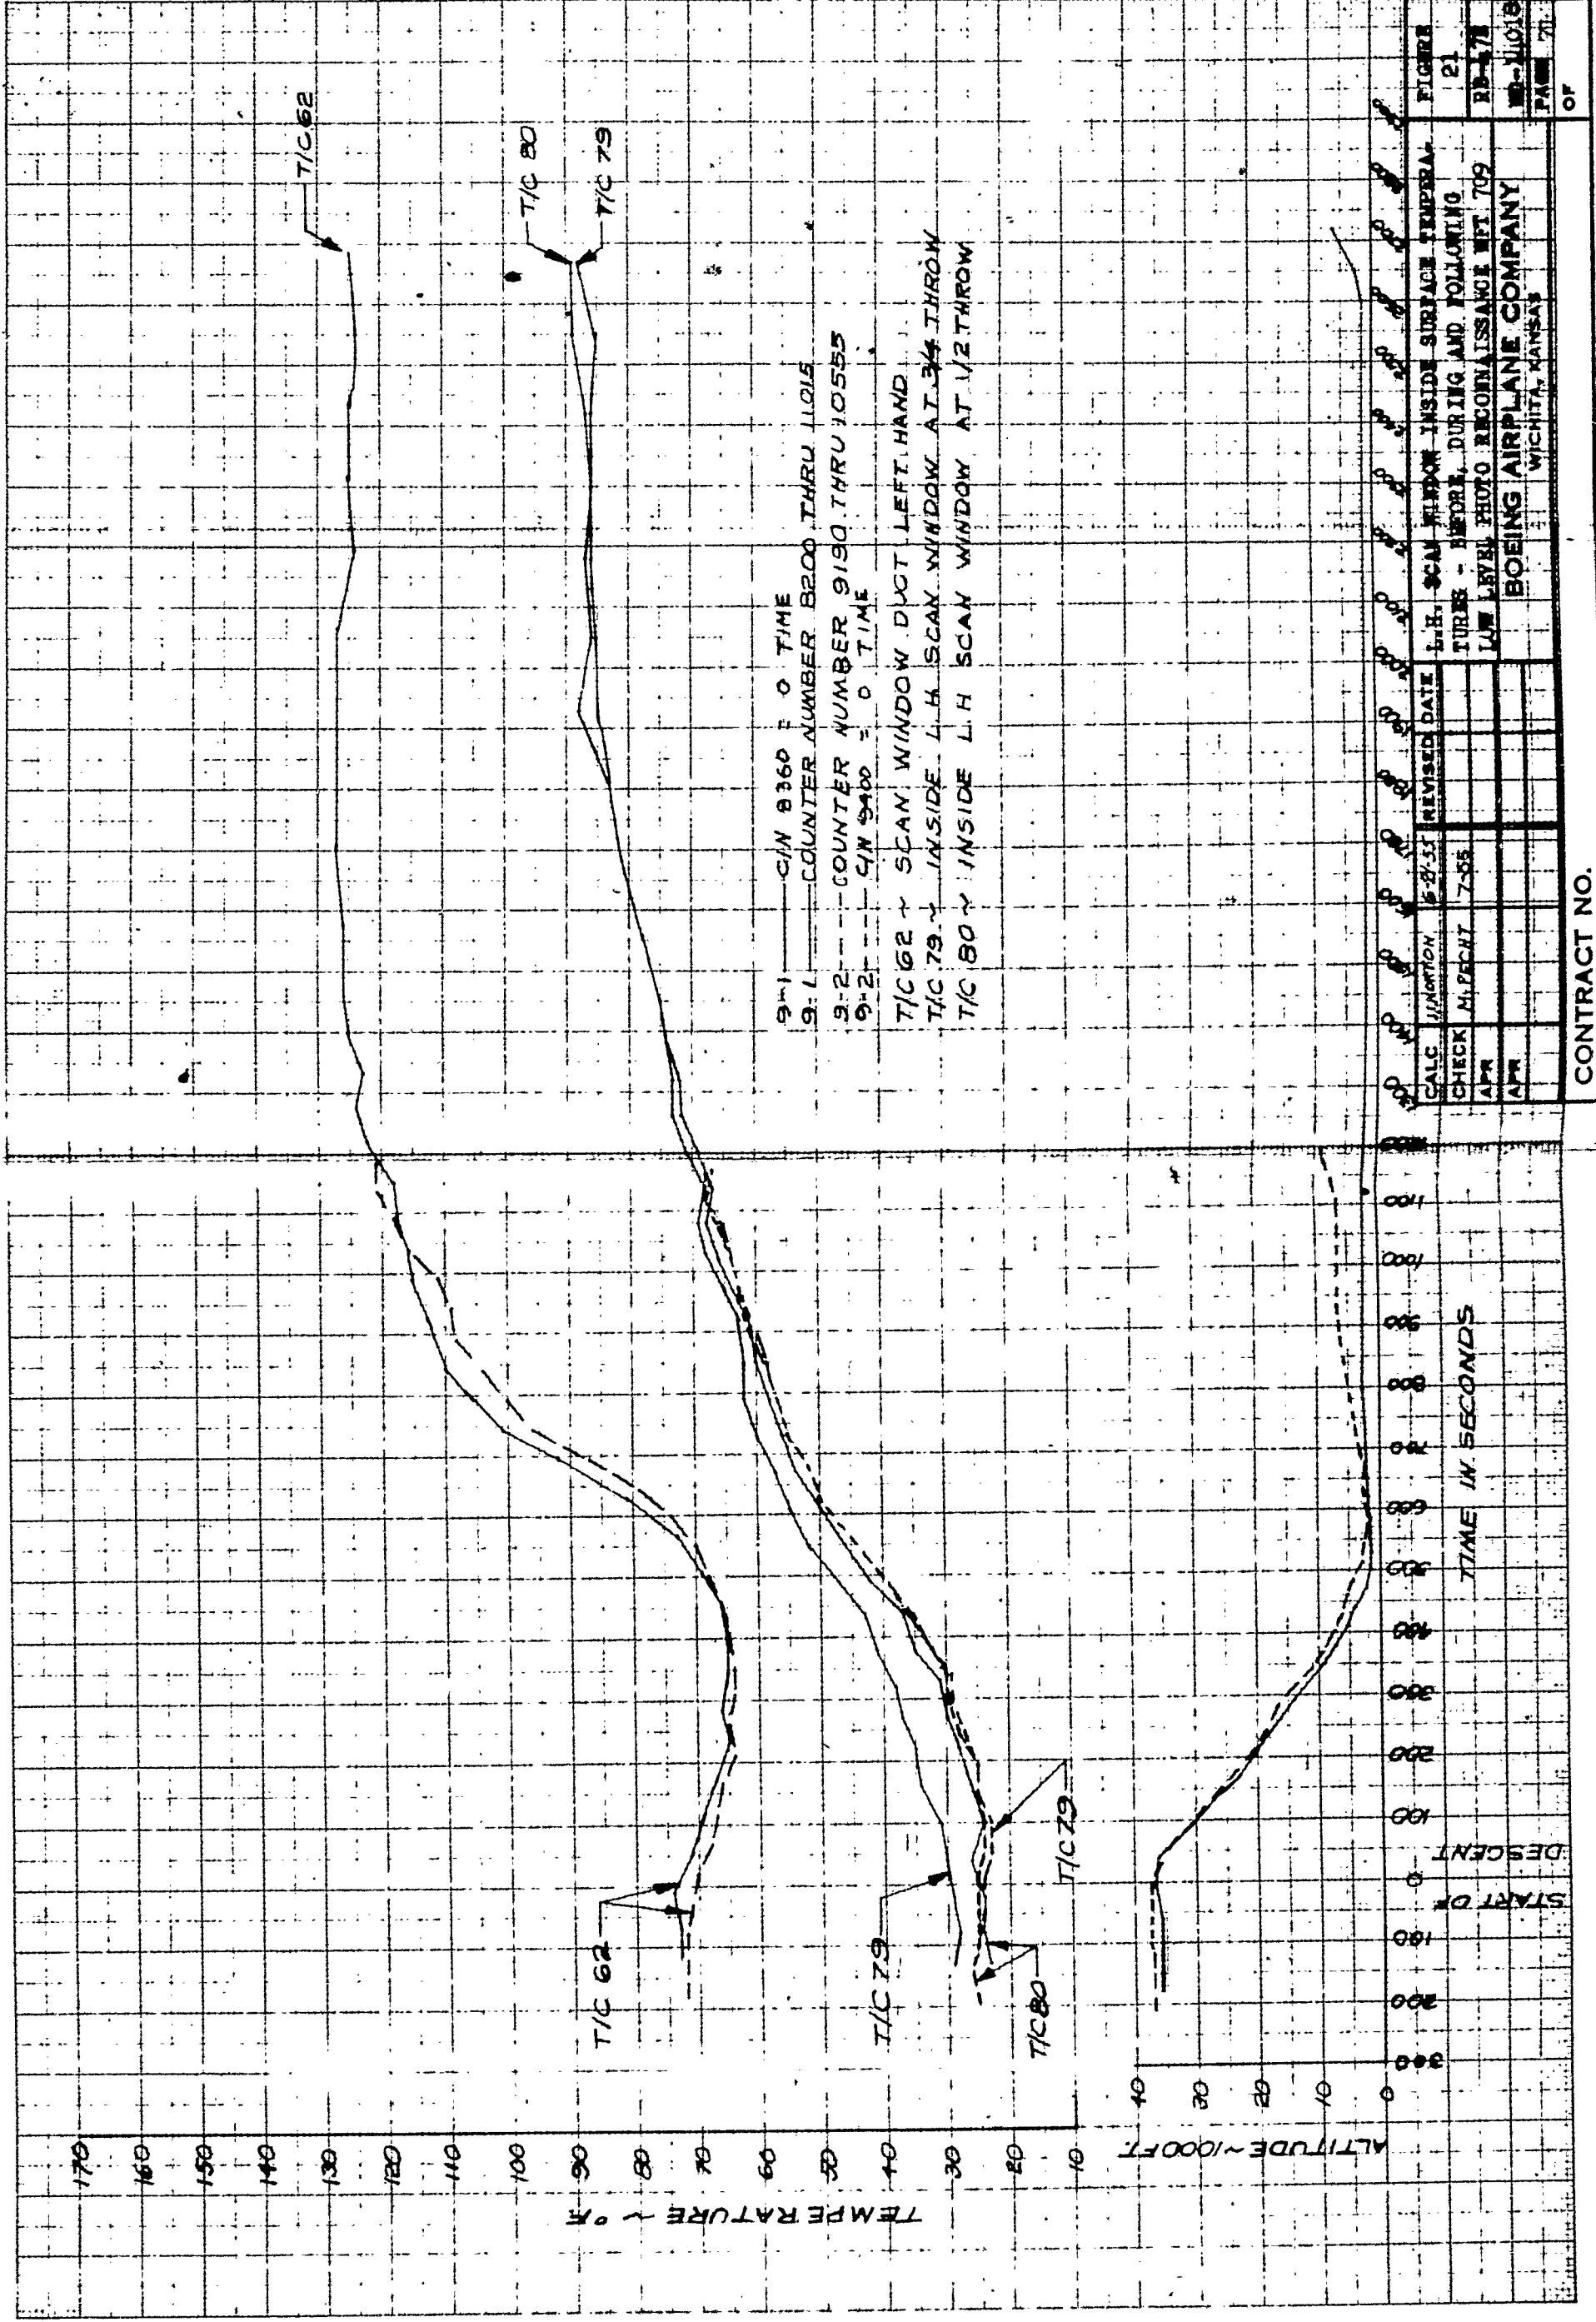
9-1 --- CIN 8360 ± 0 TIME  
 9-1 --- COUNTER NUMBER 8200 THRU 11015  
 9-2 --- COUNTER NUMBER 9190 THRU 10555  
 9-2 --- CIN 9400 ± 0 TIME  
 T/C 62 ~ SCAN WINDOW DUCT LEFT HAND  
 T/C 79 ~ INSIDE L.H. SCAN WINDOW AT 3/4 THROW  
 T/C 80 ~ INSIDE L.H. SCAN WINDOW AT 1/2 THROW

CALC. J. MORTON	5-24-55	REVISED DATE	L.H. SCAN WINDOW INSIDE SURFACE TEMPERATURES - BEFORE, DURING AND FOLLOWING LOW LEVEL PHOTO RECONNAISSANCE MFT 709	FIGURE 21
CHECK M. PECHT	7-55			RD-171
APR				WB-11018
APR				PAGE 21
BOEING AIRPLANE COMPANY WICHITA, KANSAS				OF

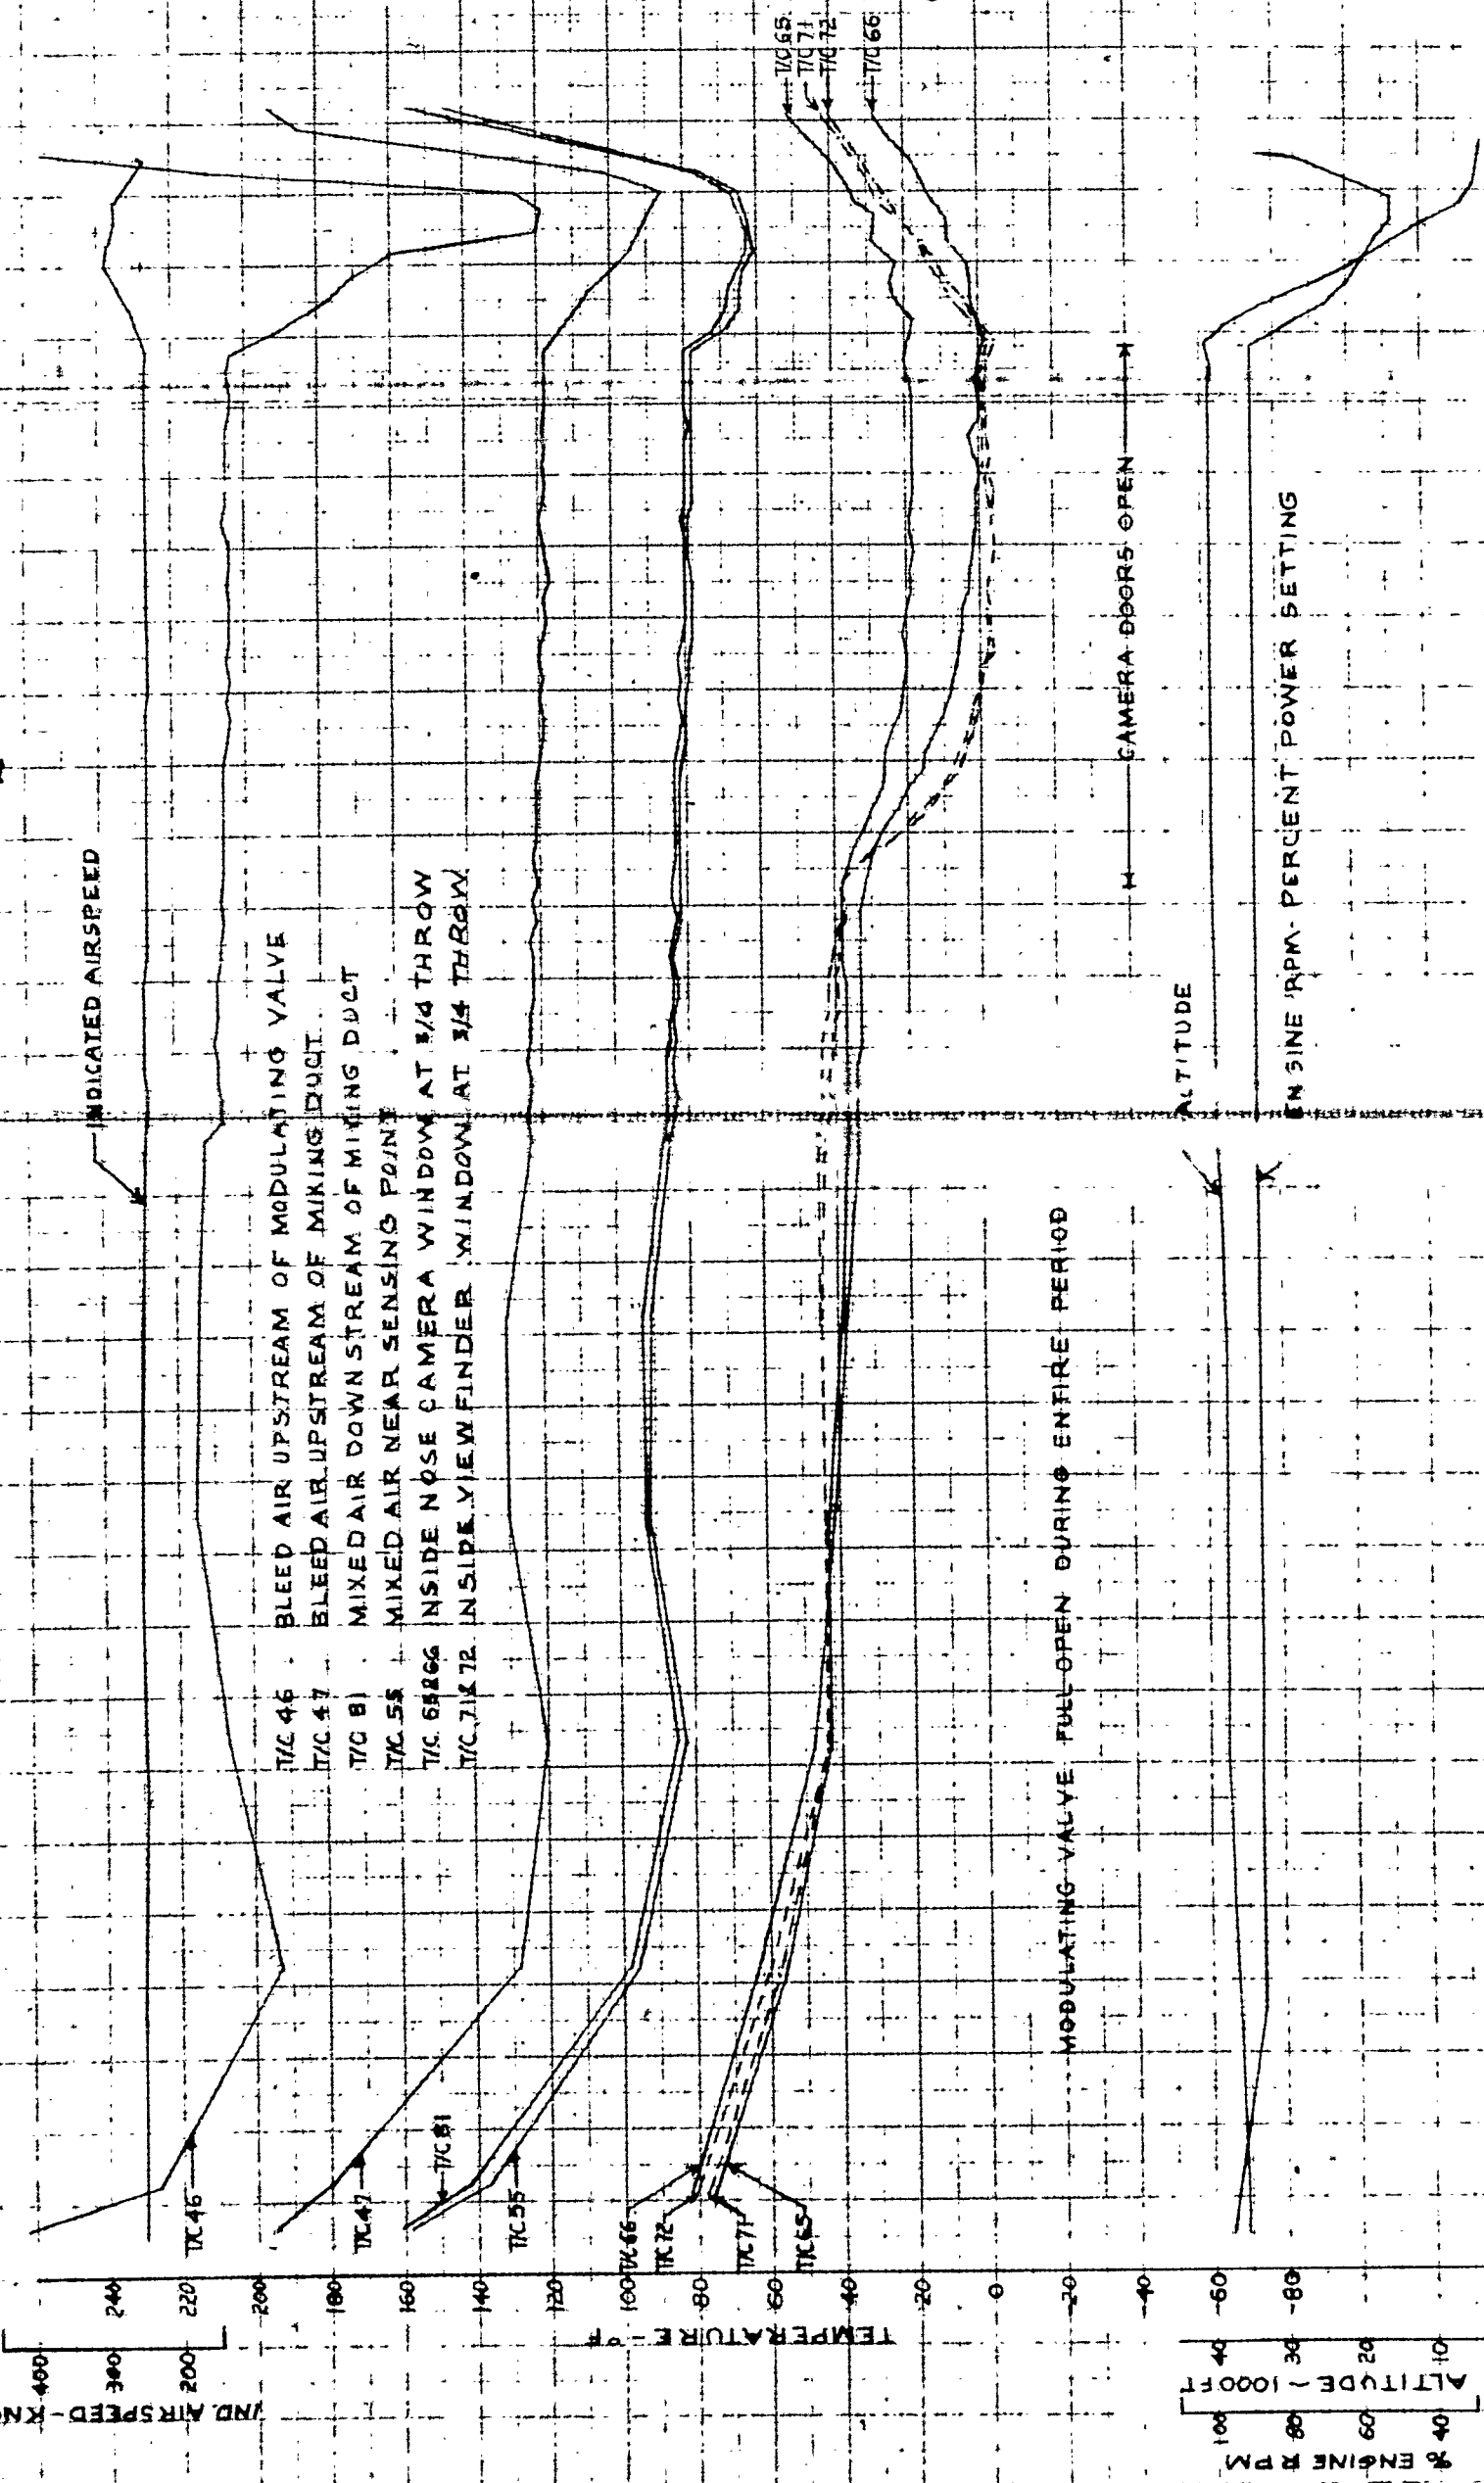
# NOSE CAMERA AND VIEWFINDER WINDOW INSIDE SURFACE TEMPERATURES WITH BLEED AND MIXED AIR TEMPERATURE DURING HIGH ALTITUDE PHOTO RUN AND FINAL DESCENT - TEST 9-1

CALC	10-22-55	REVISED	DATE	FIGURE
CHECK				22
APR				RB-47B
APR				WD-MJ019
CONTRACT NO.				PAGE 72
BOEING AIRPLANE COMPANY				OF
WICHITA 1, KANSAS

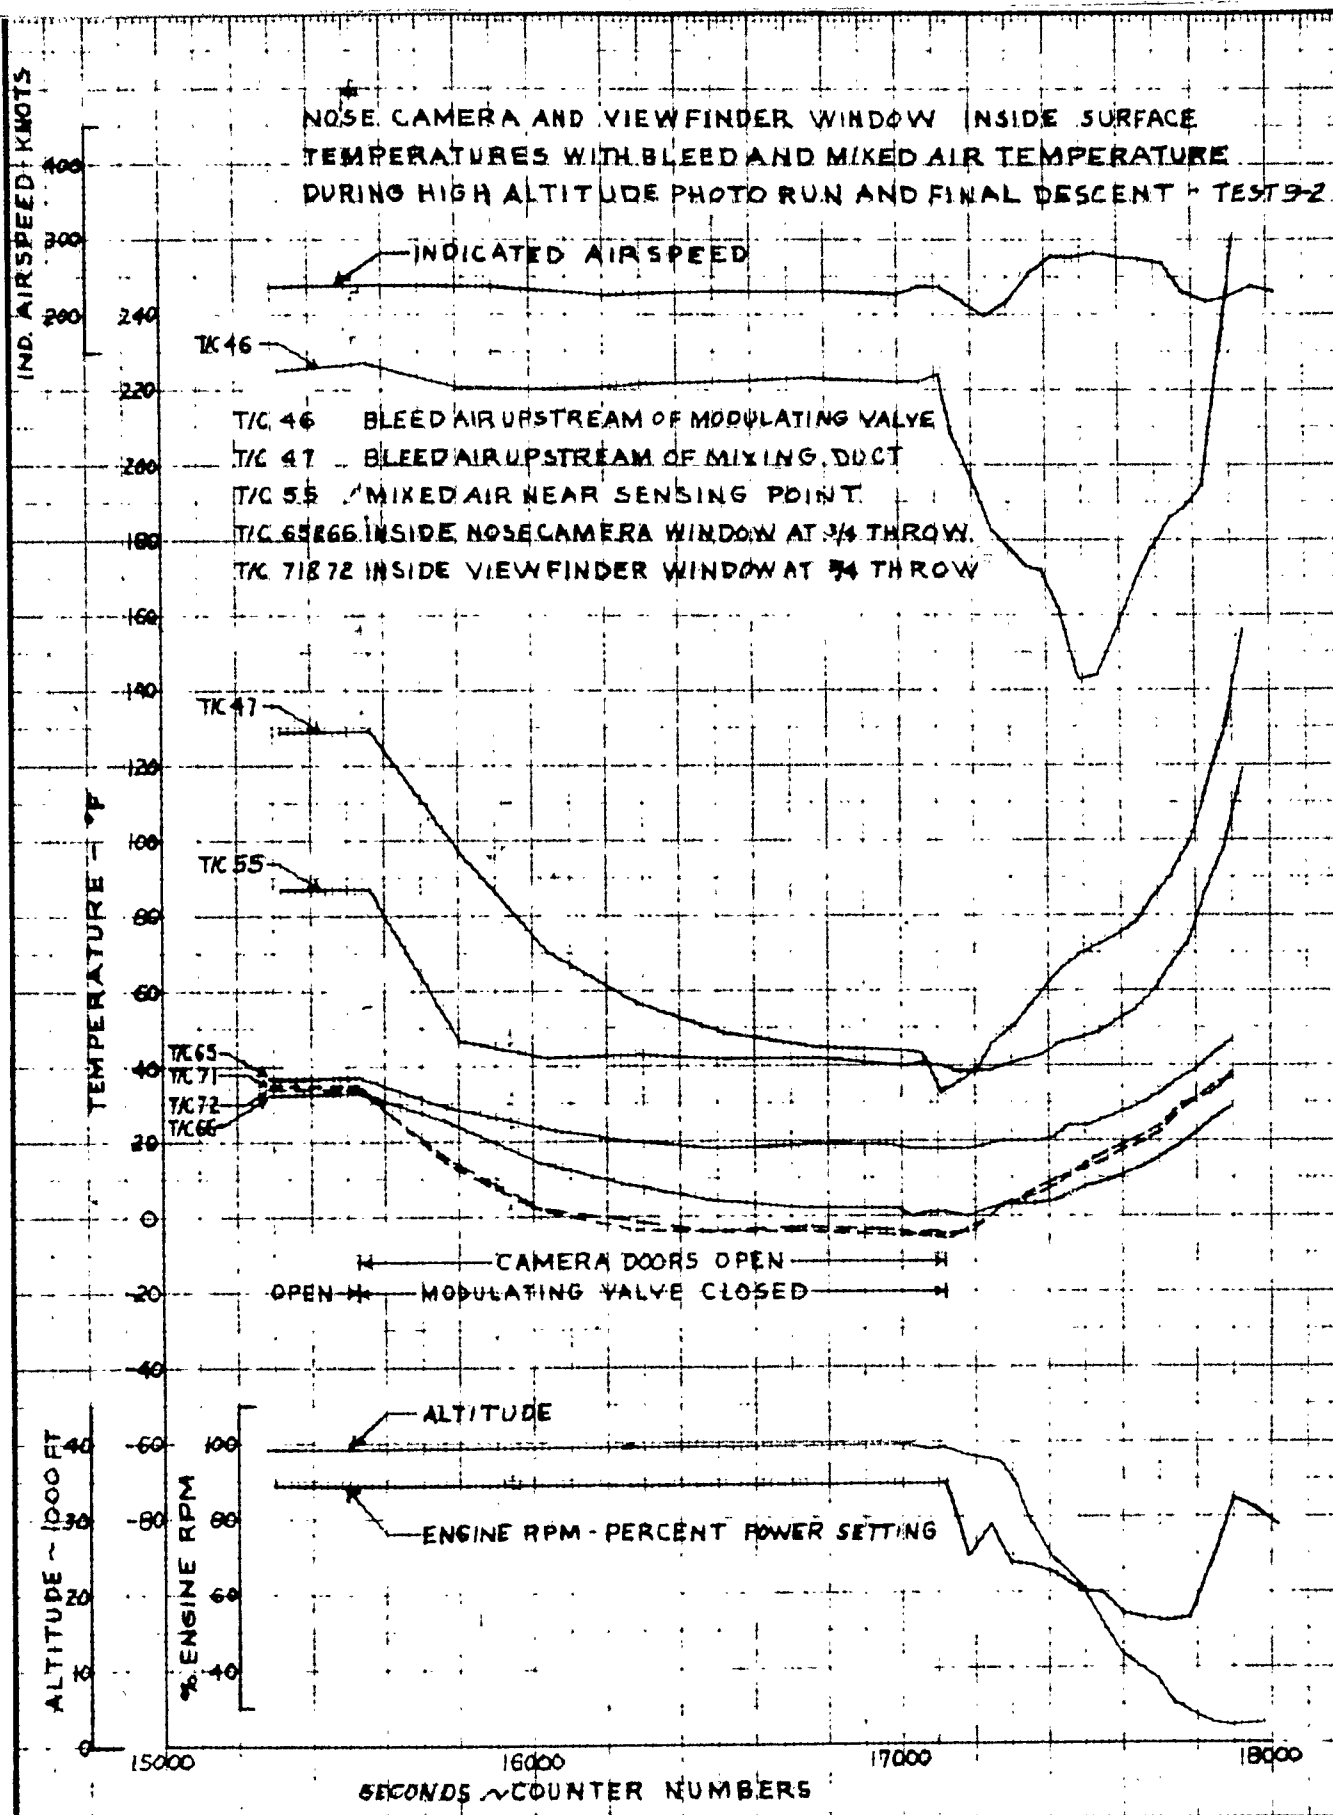
NOSE CAMERA AND VIEWFINDER INSIDE SURFACE TEMPERATURES DURING HIGH ALTITUDE PHOTO RECONNAISSANCE-WTT709 TEST 9-2

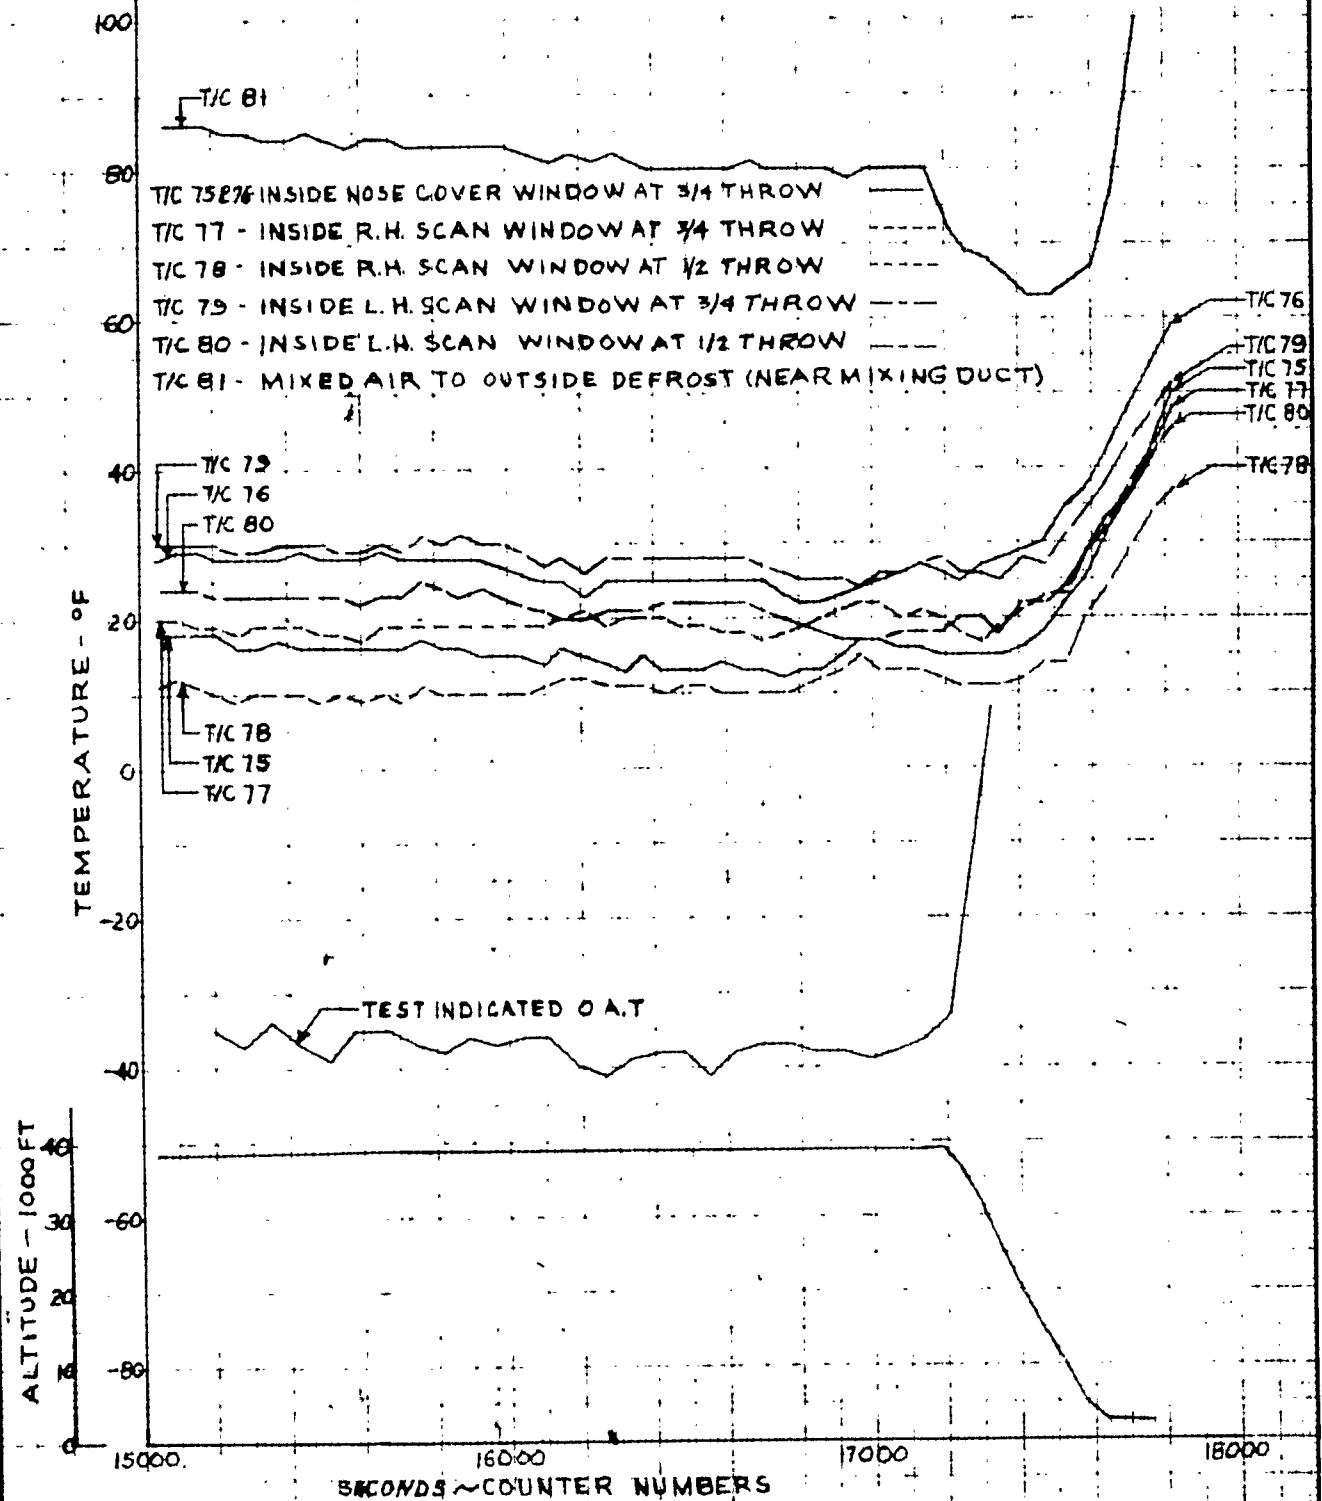
NOSE COVER AND SCAN WINDOW INSIDE SURFACE  
TEMPERATURES DURING HIGH ALTITUDE PHOTO  
RUN AND FINAL DESCENT - TEST 9-1

NOSE COVER AND SCAN WINDOW INSIDE SUR-  
FACE TEMPERATURES DURING HIGH ALTITUDE  
PHOTO RECONNAISSANCE-WET709 TEST 9-1  
BOEING AIRPLANE COMPANY  
WICHITA 1, KANSAS

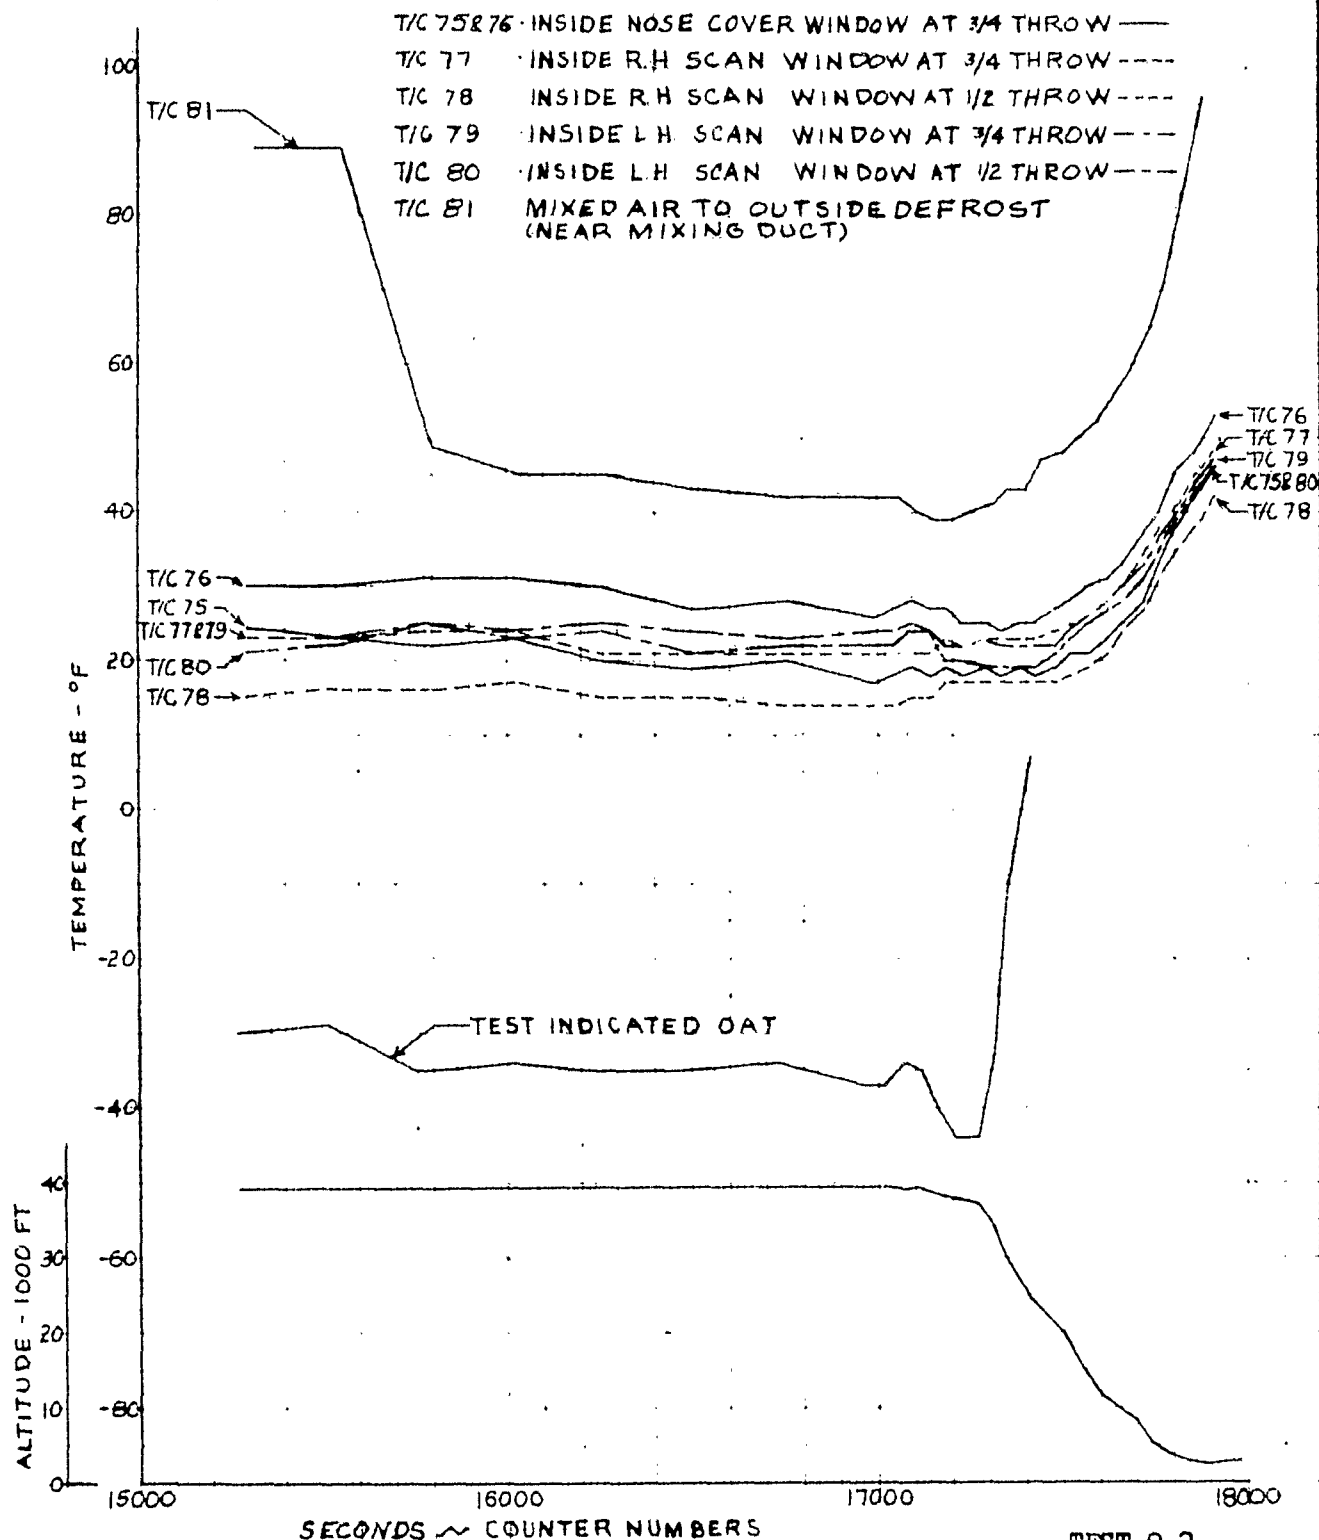
NOSE COVER AND SCAN WINDOW INSIDE SURFACE  
TEMPERATURES DURING HIGH ALTITUDE PHOTO  
RUN AND FINAL DESCENT - TEST 9-2

CALC	<i>GR</i>	12-25-53	REVISED	DATE	NOSE COVER AND SCAN WINDOW INSIDE SURFACE TEMPERATURES DURING HIGH ALTITUDE PHOTO RECONNAISSANCE-WPT709	FIGURE 25
CHECK						PR-77F
APR						WD-14018
APR					BOEING AIRPLANE COMPANY WICHITA 1, KANSAS	PAGE 5 OF
CONTRACT NO.

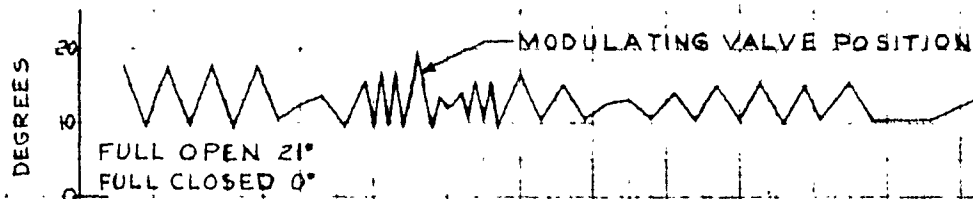
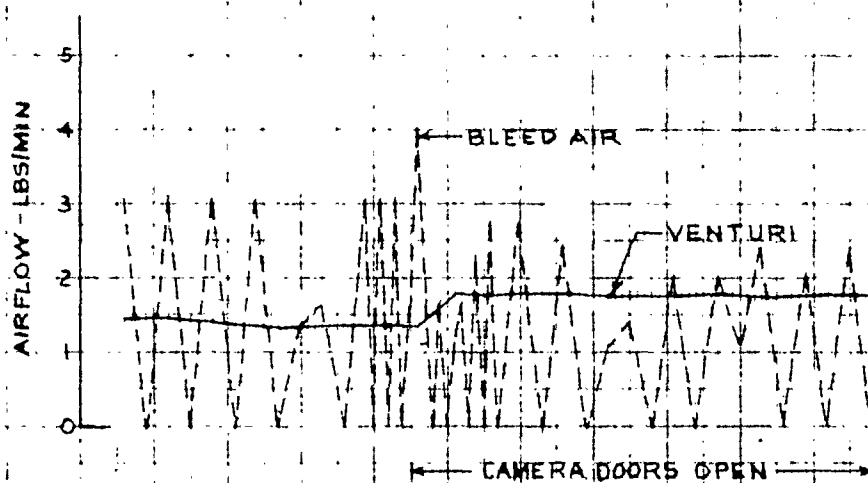
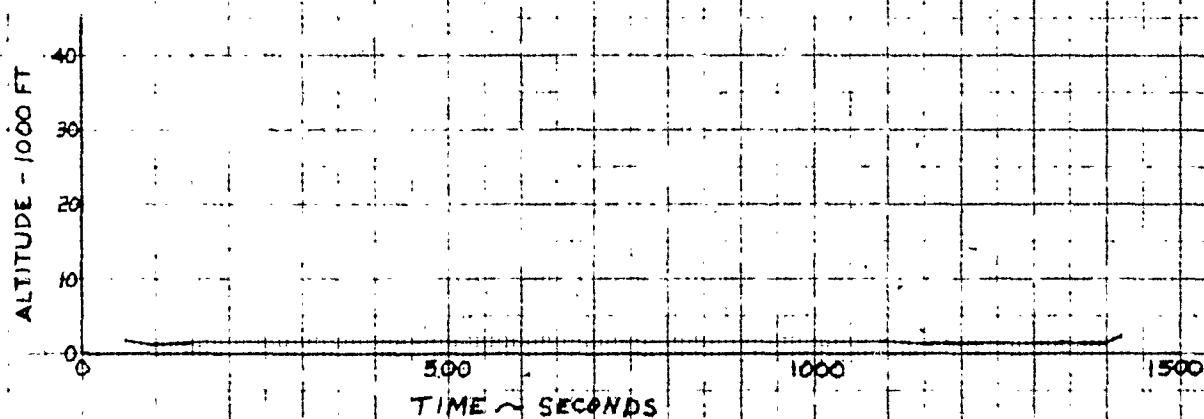
NOSE COMPARTMENT VENTURI AND BLEED AIRFLOW  
 TEST 9-4 S/N 9960 TO 11325  
 C/N 9900 = 0 TIME

DEFROST SYSTEM VENTURI & BLEED AIRFLOW  
 WFT-709 TEST 9-4

The venturi and bleed airflow are approximately equal during a steady state high altitude condition as evidenced by Figures 28 through 31. The bleed air-flow during descent and low altitude flight cannot be determined because of the type of flow instrumentation used, but it can be noted that the modulating valve did not close at all times when the camera doors were opened, as shown in Figure 28, 30 and 32 which are for tests 9-1 and 9-4. However, as shown on Figure 31 the modulation valve closed when the doors were open for the high altitude photo run of test 9-2, and the modulating valve also closed during the high altitude photo run of test 9-4. Air-flow data could not be determined during the high altitude photo run of test 9-4 because of a temperature recorder malfunction and consequently, modulating valve position was not plotted. Also, as can be noted in Figure 31, sufficient data was not obtained to allow a check of the modulating valve opening and closing time. It is also noted that the modulating valve cycling did not at any time go below 9.5° or approximately half closed. However, this could be contributed to the inadequacy of the instrument used to record the valve position.

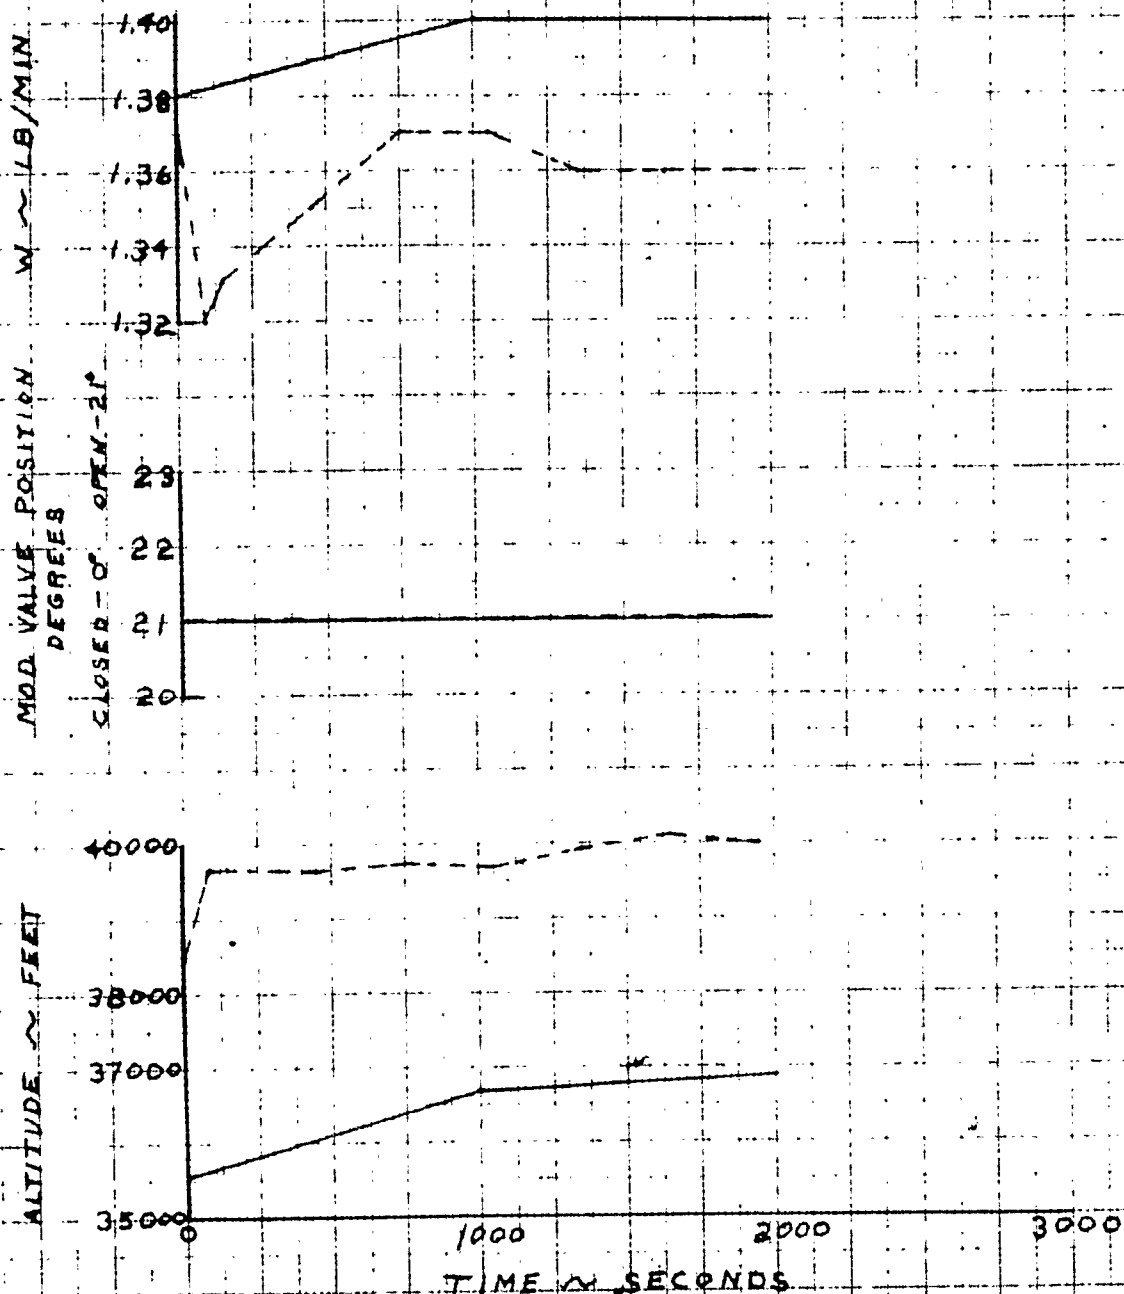
NOSE COMPARTMENT BLEED AIRFLOW  
WFT 708 TEST 8-3 C/N 2867 TO 4867  
NAVIGATORS MANUAL SHUTOFF VALVE IN  
OFF POSITION ————— C/N 2867 = 0 TIME  
TEST 8-4 C/N 10649 TO 12599  
ON POSITION — — — — —  
C/N 10649 = 0 TIME

CALC	M. PECHT	10-55	REVISED	DATE	DEFROST SYSTEM BLEED AIRFLOW WFT 708 TEST 8-3 & 8-4	Fig. 32A
CHECK	JBK	10-22-55				RB-47E
APR						WD-14018
APR						PAGE 83
						OF
CONTRACT NO.

Test data for the navigator's compartment defrosting system was also obtained during certain tests of WFT-708 "Camera Compartment Air Conditioning Flight Test of RB-47E, AF51-5258". During test 8-3, counter numbers 2867 to 4867, Figure 32, the bleed airflow was measured with the navigator's manual shutoff valve in the "OFF" position. The bleed airflow was also checked during test 8-4, counter numbers 10649 to 12599, Figure 32, with the manual shutoff valve in the "ON" position.
